# Observations and Recommendations Regarding Landslide Hazards Related to the January 13, 2001 M-7.6 El Salvador Earthquake

*By* Randall W. Jibson and Anthony J. Crone

**Open-File Report 01-141**  
**On-line Edition**

U.S. Department of the Interior  
U.S. Geological Survey

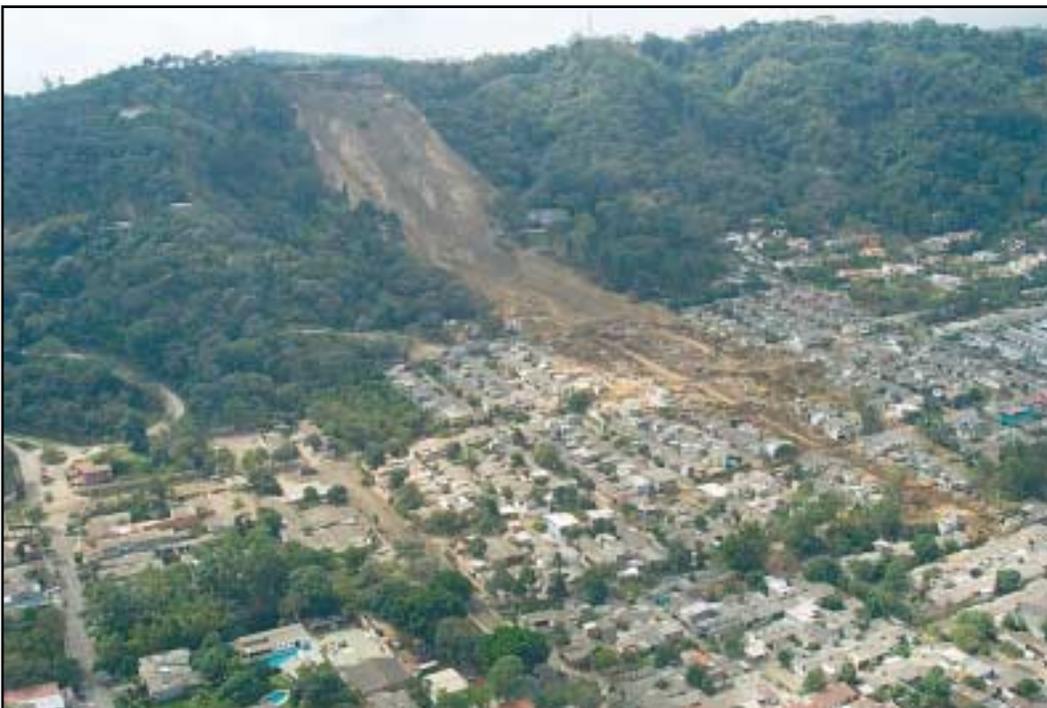
earth flow—originated at an elevation of about 1,070 m and traveled northward a distance of 700-800 m into the Las Colinas neighborhood of Santa Tecla. The vertical drop from the landslide source to the terminus is about 160 m. The volume of the landslide material is estimated at about 250,000 m<sup>3</sup>. The landslide material exposed in the headwall scarp appears somewhat moist but not saturated (fig. 2), but once this material mobilized it behaved as a semi-liquid mass with a soupy consistency; this allowed the mass to travel an unusually long distance from the base of the slope. The transformation of landslide material from solid to fluid in the absence of

**Figure 1.** Las Colinas landslide. (Photo by E.L. Harp, USGS)

Evidence on the ridge top indicates very strong levels of ground shaking that far exceed those recorded nearby. Evidence includes trees snapped off, boulders thrown from their sockets, and deep fissures along the edge of the ridge. A strong-motion recording from Santa Tecla recorded a peak ground acceleration of more than

0.7 g, which is a very high level of shaking at this distance from the epicenter (>100 km), but shaking on the ridge top appears to have been greater still. This exceptionally strong shaking, along with the presence of thick, loose to poorly consolidated, young volcanic deposits, the steep topography on the northern flank of Balsamo Ridge, and possibly the presence of a relatively impermeable ancient soil at the top of the Balsamo Formation were contributing factors to the triggering of the Las Colinas landslide.

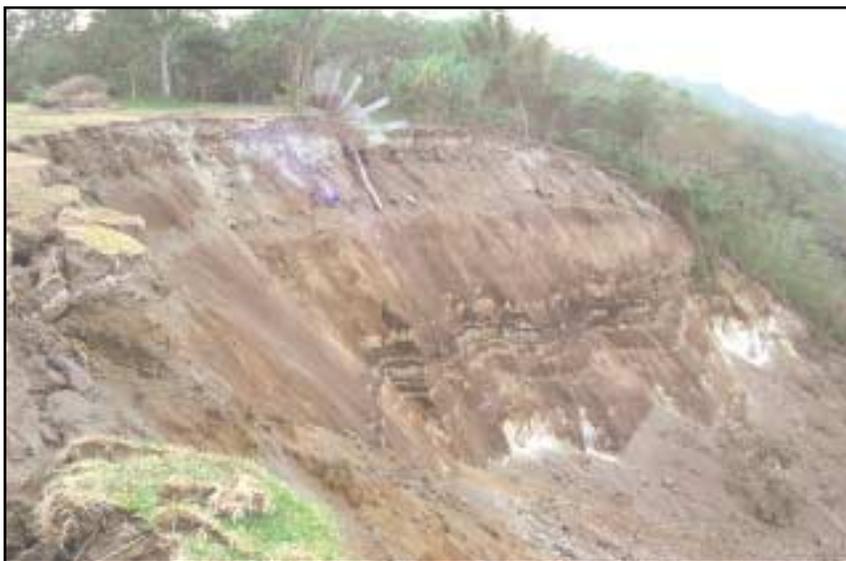
**Figure 2.** Head scarp of Las Colinas landslide (view to southwest). The whitish layer in the lower right part of the photo is the TB4 tephra. (Photo by E.L. Harp, USGS)

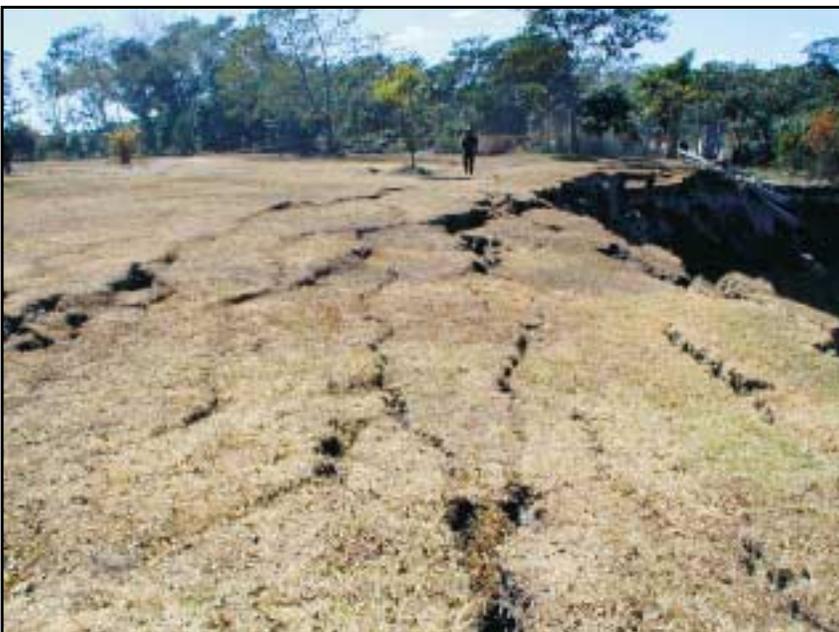
and (2) landslides that could be triggered by future large earthquakes similar to that of January 13. Landslides likely to be triggered by aftershocks or during the rainy season are likely to be much smaller than the Las Colinas slide. Cracks are present all along the crest of Balsamo Ridge, but they bound relatively small masses of earth that, if they fail, may not reach the base of the slope and are unlikely to move far

beyond the base of the slope (fig. 3). Also, loose landslide material still remains in the Las Colinas landslide scar that could move when the rains start, but the volume of this material is small enough that it is unlikely to travel far from the slope base. The potential for large slides in future large earthquakes is more difficult to define and will require detailed study, as outlined below. Listed below is a prioritized list of actions that should be taken to mitigate landslide hazards along the base of Balsamo Ridge:

**Figure 3.** Cracks above head scarp of Las Colinas landslide.

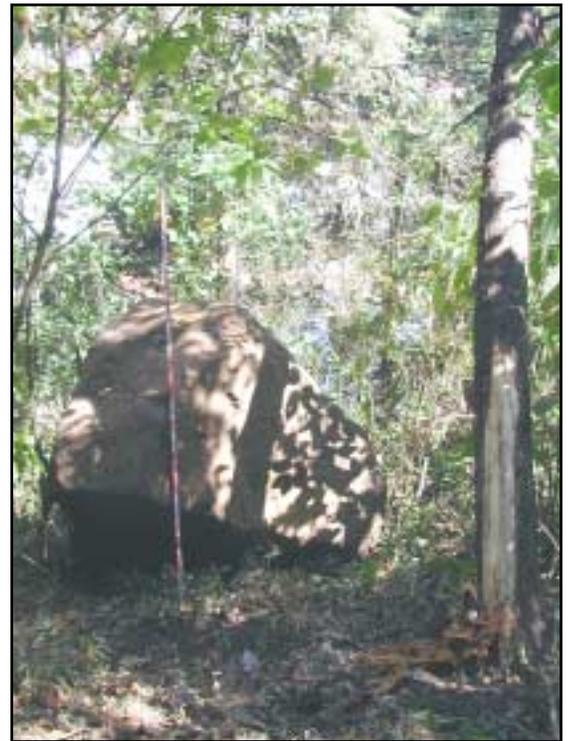
**Figure 5.** Boulder shaken loose by January 17 earthquake that came to rest near houses in Santa Elena. The measuring stick is 2 meters long. Note the scars on the tree at the right where the boulder tore the bark off the trunk.

cascade down the 30-40° slope at high enough speed to bounce and become airborne. Several such boulders are strewn throughout the forest all the way to the base of the slope, indicating that this process has been occurring for some time. During the recent M-7.6 earthquake, a 5-m<sup>3</sup> boulder released from the outcrop (see fig. 4) and moved downslope rapidly enough to knock down a 0.5-m-diameter tree and stop within 30 m

of houses at the base of the slope (fig. 5). Had this boulder continued downslope, it would have severely damaged any structure it hit. The hazard from rock falls is greatest along the western end of the ridge and lessens somewhat eastward as the rock-fall sources are higher on the slope in that direction (boulders released higher on the slope are more likely to be slowed and stopped by the thick forest covering the slope). Although heavy rainfall could also trigger rock falls in this area, the greatest hazard is probably from rocks shaken loose in future earthquakes. Houses in this area are built at the base of the slope, and houses in the uppermost part of this neighborhood face the greatest risk.

**Recommendations:** Several methods exist for mitigating rock-fall hazards. At the rock-fall source, loose boulders can be bolted into

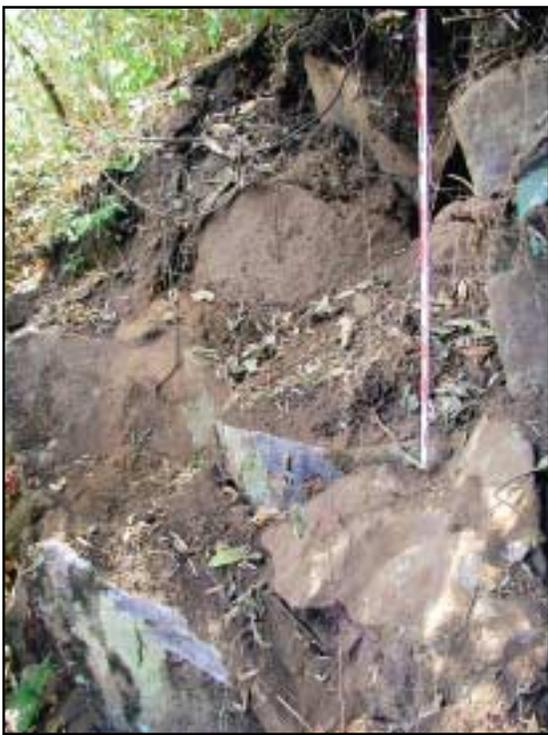
**Situation:** A steep ridge extends along the southwest edge of Santa Elena. Massive, hard lava flows crop out on the upper part of this ridge, and these rock outcrops produced rock falls during the earthquake. Fractures in the rock outcrops create rock blocks 1-20 m<sup>3</sup> in volume (fig. 4) that can be shaken loose by earthquake shaking; the blocks then

**Figure 4.** Rock-fall source on ridge above Santa Elena. The boulder shown in Figure 5 came from this source.

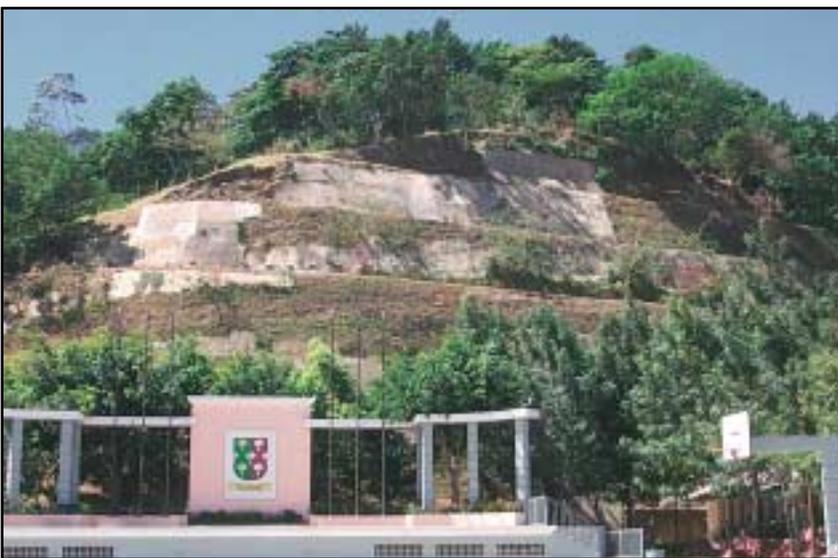
**Situation:** The La Floresta school for girls has been evacuated since the M-7.6 earthquake because of structural concerns as well as concerns about the stability of the cut slope behind the school. The school is built at the foot of a cut slope that is about 40 m high with an average slope of about 60° (fig. 6). The slope is benched; benches are about 2 m wide with culvert drains and are separated by 60-70° risers that are

**Figure 6.** Cut slope above La Floresta school for girls. Scar on upper left part of slope is a small landslide triggered by the January 13 earthquake.

The cracks on the top of the ridge appear related to localized amplified ground shaking that caused ridge-top spreading. There are small, shallow landslides in the road cut on the back side of the ridge, but there is no evidence that the cracks on top of the ridge are related to landsliding above the school. The slope between the ridge crest and the cut slope is only moderately steep, and this makes a Las Colinas-style failure very unlikely at this site. The more immediate concern should be the stability of the cut slope above the school.

**Recommendations:** The material on the top tier of the cut slope that failed during the earthquake needs to be removed and the cracks sealed before the rainy season begins to prevent mobilization of the failed material, which could move rapidly downs-

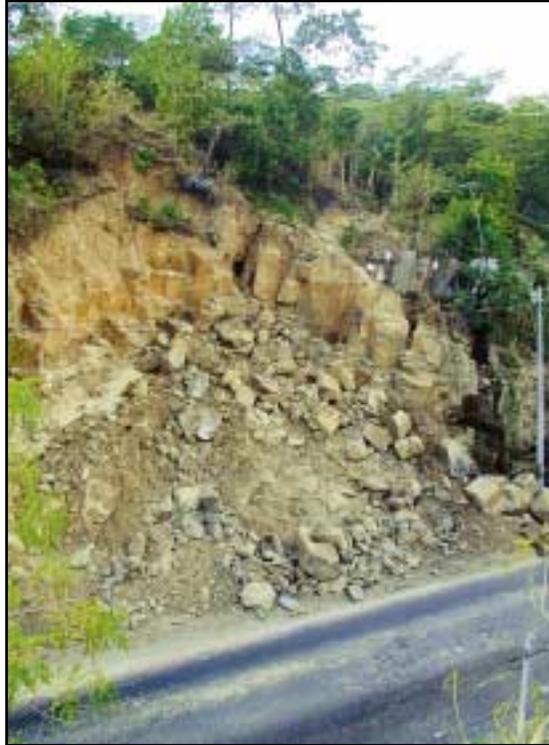
**Situation:** The earthquake triggered a rock fall having a volume of about 2,500 m<sup>3</sup> from the road cut at this location (fig. 7). One house was

**Figure 7.** Rock fall between Zaragoza and El Transito.

destroyed in the initial rock fall. Several additional houses are located along the new rock-fall scarp. The rock mass below these houses is fractured and dilated and is at great risk of failing in aftershocks, heavy rainfall, or future large earthquakes (fig. 8). This poses risks to both the residents of the houses and motorists on the road below.

**Recommendations:** Houses along the fresh scarp should be removed immediately and the residents relocated. Rock-fall material from the earthquake should be removed from the landslide scar, and the rock face should be graded back to a more stable slope angle.

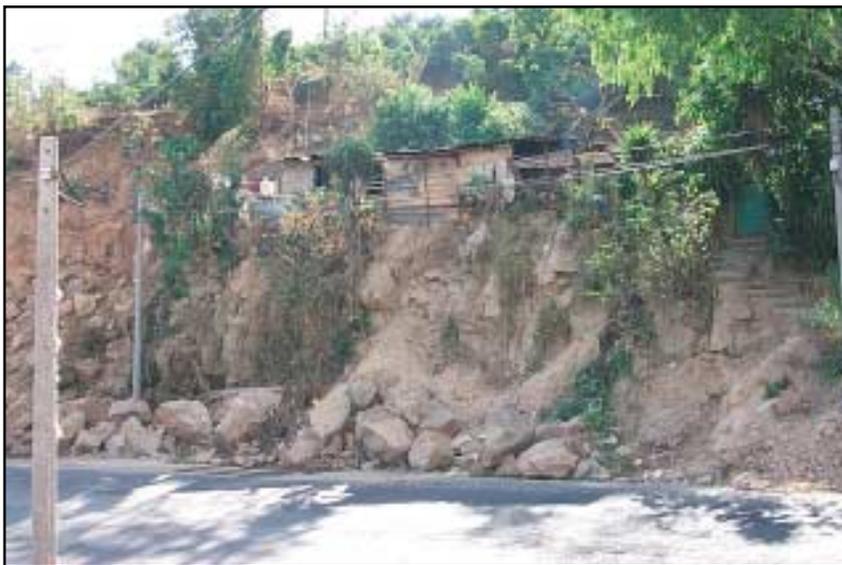
**Figure 8.** Houses along rock-fall scarp between Zaragoza and El Transito.

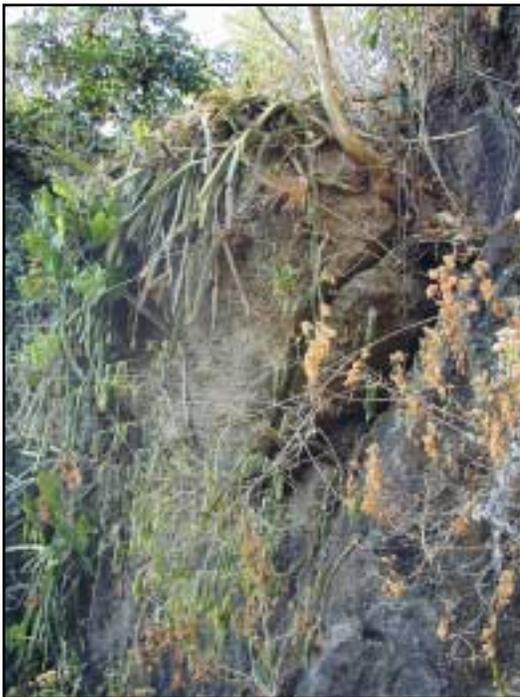
**Situation:** Several houses are located below and near vertical rock faces that produced rock falls during the earthquake. The faces are moderately fractured and could produce future rock falls during earthquakes or intense rainfall. The face on the east end of this area is particularly hazardous and has a large (10 m<sup>3</sup>) boulder that is detached and ready to fall (fig. 9). Several houses are directly in the path of this boulder.

**Figure 9.** Precariously perched boulder above houses in Santa Teresita.

**Recommendations:** Removal of the precariously perched boulder from the eastern rock face would be the most effective course. This will require attaching cables to the rock and either pulling it to the top of the slope with heavy equipment or causing it to fall with restraints so that it will not continue into the houses below. Cable fences to catch boulders could be installed in other

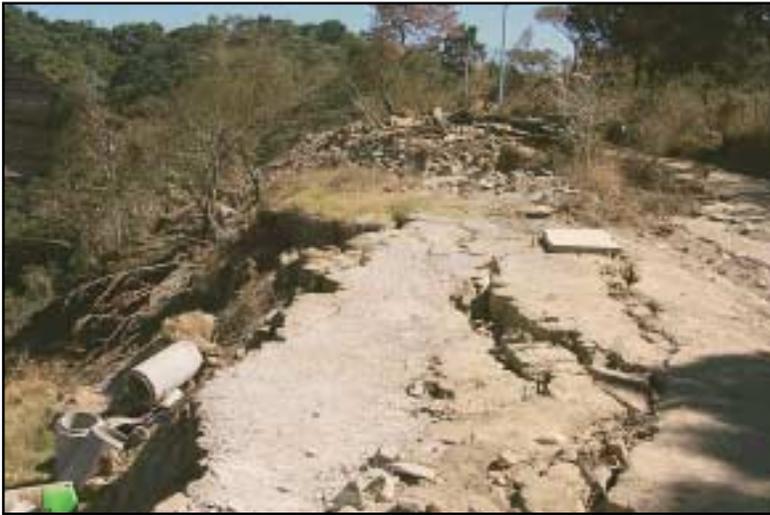
**Situation:** Almost the entire length of the road extends along a narrow, steep-sided ridge. The ridge experienced amplified ground shaking and is thoroughly shattered along most of its length (fig. 10). The ground surface is fissured and shattered, road cuts have failed continuously, and nearly all structures have collapsed. The road is in very poor condition—it is covered by as much as 0.5 m of fine, powdery dust, and the failed road cuts are depositing more material on the road (fig. 11). When this material gets wet in the rainy season, the road is likely to be impassable. On the east end, the road traverses a large, deep debris slide triggered by the earthquake that is similar to the Las Colinas landslide.

**Figure 10.** Shattered ridge near Comasagua.

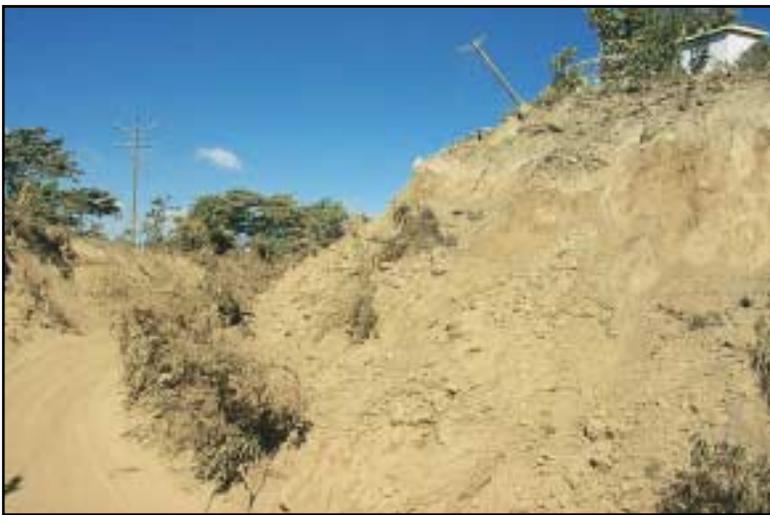
**Figure 11.** Road-cut failures on road from Las Delicias to Comasagua.

**Recommendations:** The road cuts should be stabilized by regrading and removing failed material. The road itself needs to be regraded to remove the thick layer of dust; it should then be graded with gravel or other aggregate to provide stability to the road base. This needs to occur before the rainy season if the road is to remain open. Keeping the road open across the large landslide at the east end may be very difficult. It may require building retaining walls above the road to catch additional landslide material that is likely to fall from the scarp area.

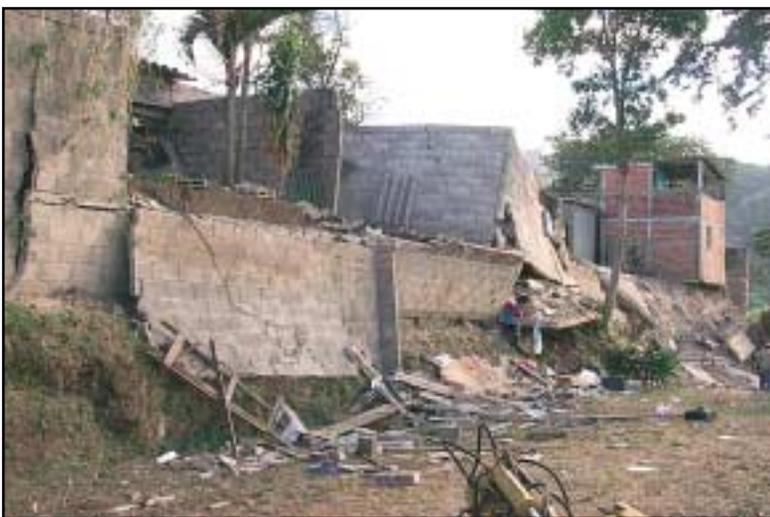
**Figure 12.** Damage from strong shaking and landsliding at Alpes Suizos.

**Situation:** Several houses built on the edge of the slope overlooking the highway were severely damaged during the earthquake by a combination of strong shaking and failure of the slope beneath the houses (fig. 12). The rear half of the houses detached in many cases and moved several centimeters toward the slope. Houses across the street to the east also had serious cracking and damage but not as severe. The area is currently evacuated, and many residents are eager to repair and rebuild their homes.

**Recommendations:** The likelihood of continuing slope movement is high, both in earthquakes and rainfall, and the slope movement will be difficult to stabilize economically and reliably. The cost of slope stabilization will likely be much greater than the value of the affected houses; therefore, the houses on the outer edge of the slope should be condemned and removed rather than repaired. The houses on the east side of the street could be repaired and salvaged if a detailed study indicated that the slope failure will not extend that far behind the edge of the slope.

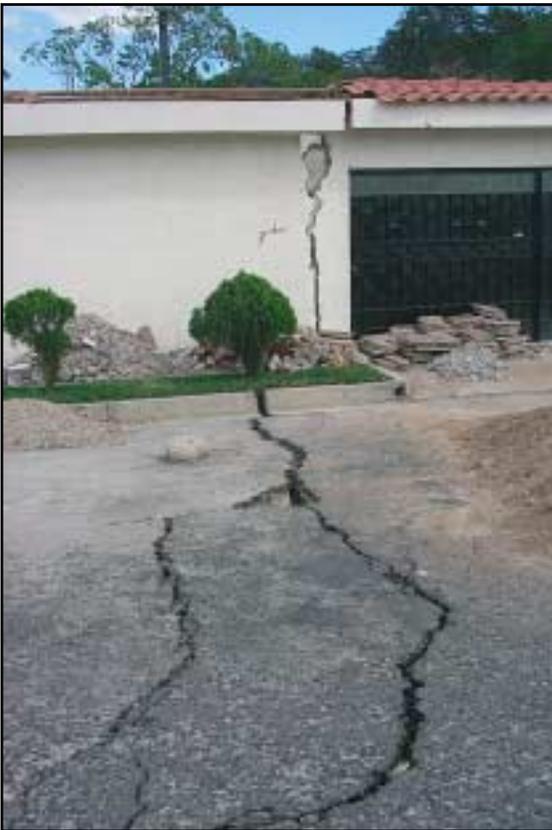
**Situation:** Cracks as wide as 10 cm opened during the earthquake. The cracks separate road pavement and extend through several houses, causing serious damage (fig. 13). The cracks appear to occur near the boundary of the cut slope and the fill slope, a situation that has been observed in earthquakes elsewhere. Renewed cracking in future earthquakes is likely, and failure of the edge of the fill during the rainy season is possible.

**Figure 13.** Cracks along the edge of a fill slope at La Cima 3.

**Recommendations:** Cracks should be carefully filled and sealed before the rains begin. Homeowners should be informed that renewed cracking is likely in future earthquakes and rainy seasons. A detailed geotechnical study should be conducted to determine the stability of the edge of the fill in the rainy season. Homes below this fill slope may need to be temporarily or permanently evacuated while this study is being conducted.

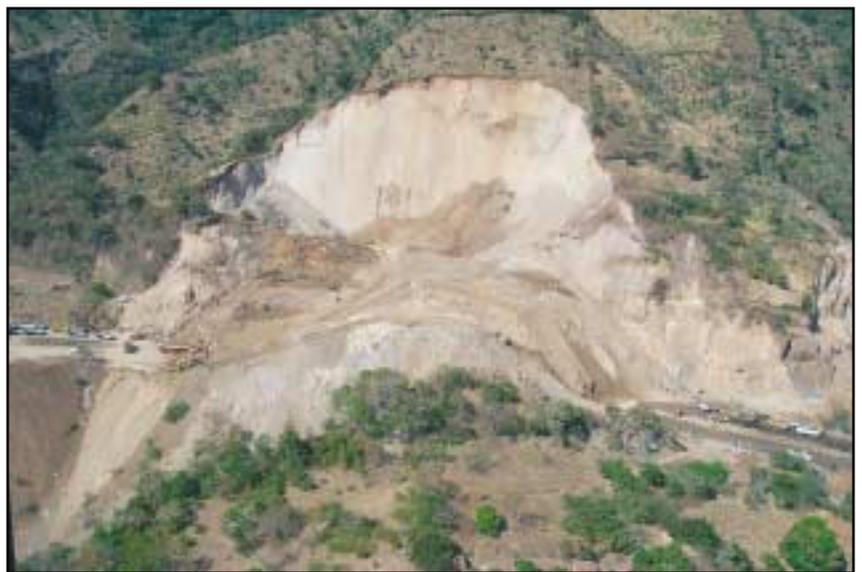
**Situation:** The earthquake triggered a massive debris slide from a road cut on the Pan-American Highway (fig. 14). The slide is approximately 250 m wide at its base, 120 m high, and 25 m thick, which yields an estimated volume of 500,000-700,000 m<sup>3</sup>. The main scarp of the landslide formed along the surface of a south-dipping normal fault, which created a zone of weakened, sheared material

**Figure 14.** Landslide blocking the Pan-American Highway near San Vicente. (Photo by E.L. Harp, USGS)

that facilitated slope failure during the earthquake shaking. Excavation of the landslide deposit from the road was almost complete as of February 7, 2001. Local residents stated that the road cut had been oversteepened by people excavating rocks from the cut to sell as building aggregate. We inspected the slope above the crown of the landslide and saw no open cracks or other indications of impending failure of material above the scarp, but near-vertical scarps in weak material commonly retreat through time, so small landslides from the scarp should be expected; most of these will come to rest on the remaining landslide deposit that is above the road. Landslide material removed from the roadway was dumped over the edge of the slope below the road. This uncompacted fill slope is highly susceptible to failure during rainy periods or future earthquakes, which could endanger homes downslope.

**Recommendations:** Water will tend to collect on top of the remaining landslide deposit, which is above the highway. A drainage system should be installed to keep as much water as possible from the top of the landslide material. The cut slope above the road in the landslide material is rather steep and can be expected to produce small- to moderate-size landslides that could close the road and endanger motorists in rain storms or moderate to large earthquakes; therefore, this cut may need to be laid back to a gentler slope angle. The waste slope below the road will be diffi-

cult to stabilize and will require a detailed geotechnical study to recommend solutions.

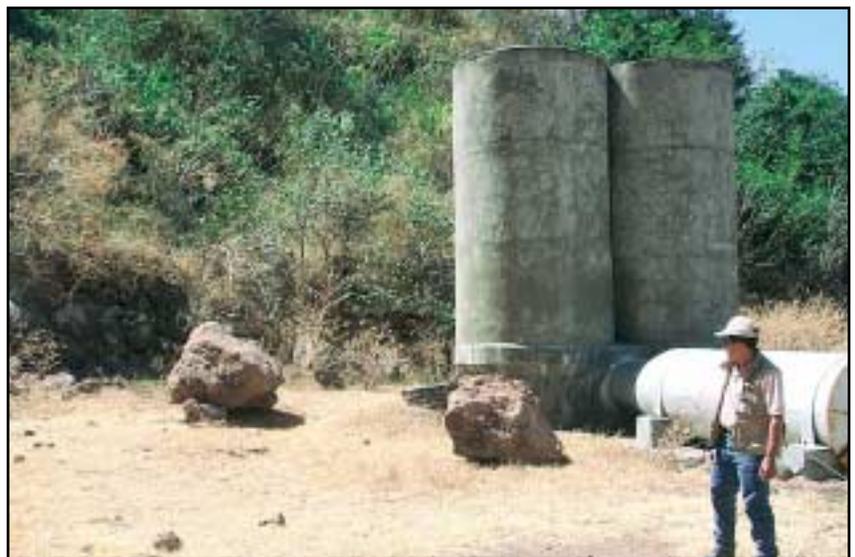
**Situation:** A rock fall of several hundred cubic meters occurred on the steep slope behind the well; the slope is the scarp of an older, larger landslide. Several boulders from the rock fall stopped within a few meters of the well equipment; the biggest single boulder is about 5 m<sup>3</sup> (fig. 15). Another landslide heads just below the road to the well. The road itself has cracks parallel to the edge of the slope.

**Figure 15.** Boulders from rock fall above geothermal well near Berlin.

**Recommendations:** More boulders are likely to come off the slope above the well in future earthquakes and heavy rain storms. The best solution may be to construct a cable fence to catch and stop the boulders at the base of the slope. The fence will need to be designed by a qualified rock engineer and constructed to specifications if it is to perform properly.

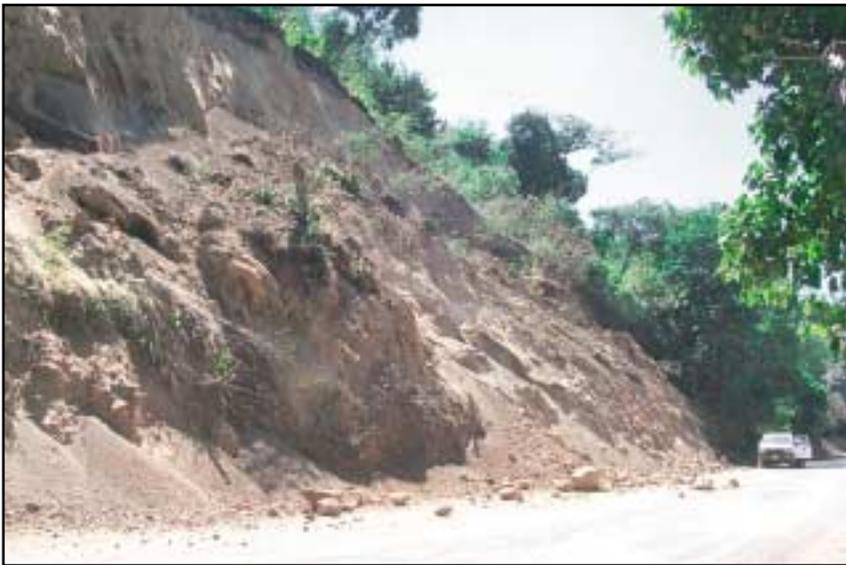
**Situation:** The earthquake triggered many rock falls along the road having volumes as great as to several hundred cubic meters. The largest of these (at the coordinates given above) is particularly hazardous (fig. 18). Many dilated fractures have openings of 10 cm or more. Many boulders are precariously perched and ready to fall. Modest rainfall or earthquake shaking will bring down more material unless immediate remedial work is undertaken

**Figure 16.** Landslide on road from Berlin to Alegria.

**Recommendations:** The road cut needs to be stabilized by removing loose boulders and perhaps using additional rock engineering measures to stabilize the rocks.

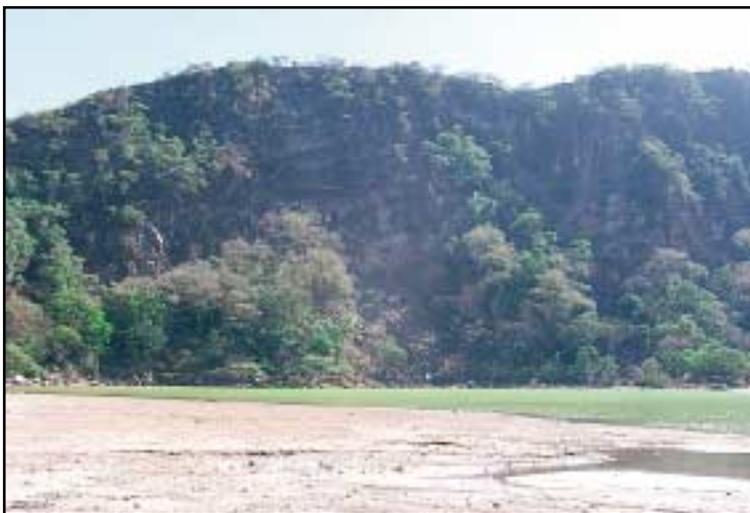
**Figure 17.** Rock falls from slopes surrounding Laguna Alegria.

**Recommendations:** Clear the road of rock-fall debris and be prepared for future rock falls. Post signs warning visitors of the possibility of rock falls.

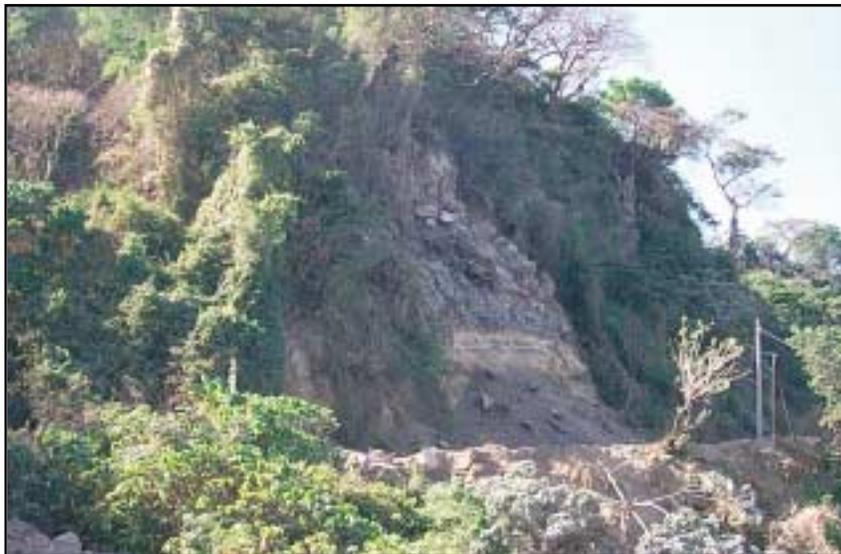
**Figure 18.** Rock fall on road from Alegria to Santiago de María.

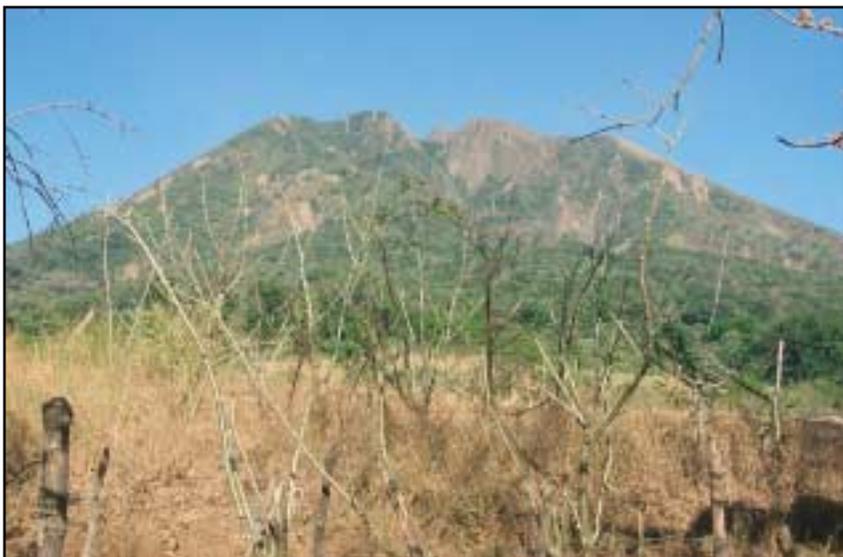
**Situation:** Many large landslides occurred on the flanks of Usulután Volcano (fig. 19). They probably affect only the coffee plantations on the slopes, but sediment from these land-

**Figure 19.** Landslides from the flanks of Usulután volcano.

slide deposits will wash into drainages over time and could cause sedimentation problems downstream.

**Recommendations:** Plantation owners should address landslide problems. Communities downstream from the flanks of the volcano should be warned of possible sedimentation issues in the future.

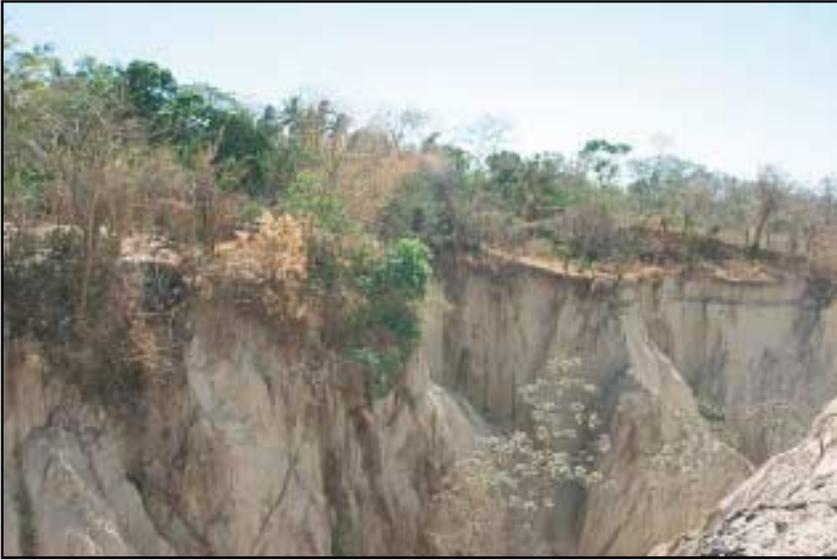
**Situation:** This town is built on a very thick layer of white, powdery volcanic tephra. Deep gorges have been eroded into the ash deposits on the edge of town. These gorges have nearly vertical walls 70-80 m high and are about 50 m or more wide. The earthquake triggered massive failures along the walls of the gorges; blocks and slabs of material hundreds to thousands of cubic meters in volume cascaded to the base of the very steep slopes (fig. 20). Numerous cracks and fissures parallel to the edge of the gorge and as far as 30 m from the edge define additional slabs of material that are likely to fail in the rainy season or in future earthquakes. The head of one gorge is already undermining the edge of a street in the town, and headward erosion will undermine this street until it is

**Figure 20.** Failures of near-vertical slopes in San Pedro Masahuat.

impassible. The soccer field near town is near the edge of a gorge. Cracks extend across the length of the field parallel to the edge of the bluff. The cracks have 1-3 cm of displacement downward and toward the bluff edge. These cracks probably define an incipient landslide triggered by the earthquake. This slide is not likely to move catastrophically in the rainy season, but it may experience some additional movement. Future earthquakes are also likely to renew movement at this site.

**Recommendations:** The ongoing enlargement of the gorges through headward erosion and lateral retreat of the walls is an continuing natural process that cannot be practically or economically controlled. Therefore, residents and local officials need to

accommodate this situation and plan to adapt to the inevitable consequences. The first priority is life safety; therefore, houses very near (within a few meters) the current edge of the gorge need to be removed and the residents relocated. Additionally, houses between large cracks parallel to the edge of the gorge and the edge of the gorge itself may also need to be removed; in such situations, the houses are on a potential landslide block that could fail catastrophically during earthquakes or the rainy season. A thorough investigation of the locations of cracks should be made by carefully inspecting areas along the edge of the bluff and recording houses with nearby cracks. Filling open cracks with dirt or cement will prevent infiltration of water in the rainy season and may delay the failure of new areas outlined by cracks. The second priority is to make a long-term plan to accommodate the retreat of the walls of the gorge. Local officials may want to establish a set-back limit from the edge of the gorge. A limit of about 30 m may be reasonable, but the limit should be set based on the observed distance of earthquake-related cracks from the edge of the bluff. Homes within this 30-m set-back zone would be scheduled for relocation over the next few years as resources are available. This will allow the natural process of bluff recession to occur within a safe zone where no houses exist. The street at the head of the gorge will become impassible soon, and plans should be made immediately to relocate this street.
